Wild Warwickshire

Saxon Mill Carr Abiotic Features Survey

April 2009

SAXON MILL CARR ABIOTIC FEATURES SURVEY

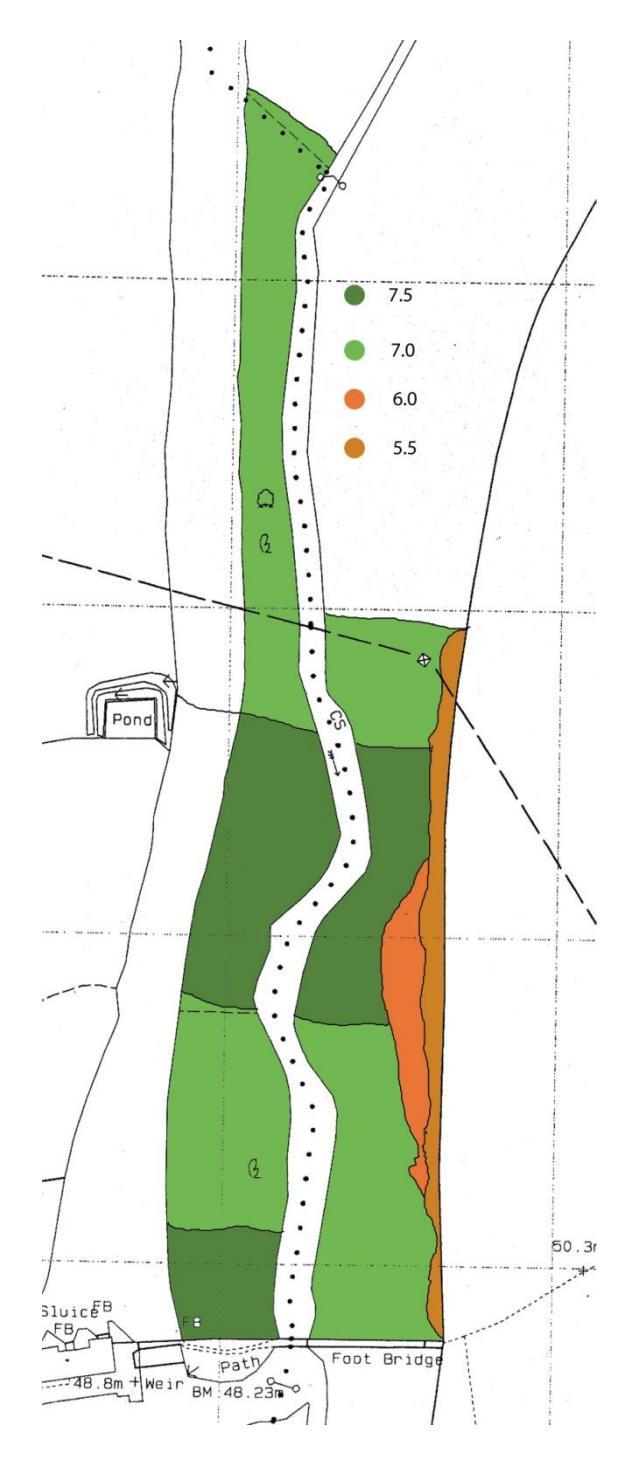
Figure 3 Soil pH

The soil samples were collected throughout the site. These samples cover a narrow range of pH's and appear to suggest a Sandy Loam over a Clay base in some regions.

Sandy soil occurs along the hedgerow it is also along this stretch that the soil is at its most acidic.

All the analyses indicate that the site is unpolluted. The water is neutral and lacking in nitrogen contaminants. The soil likewise is fairly rich. Most of the site is Sandy Loam or Loamy Sand with some areas of Silty Clay. These areas of clay correlate with the places in which standing water remains after flooding.

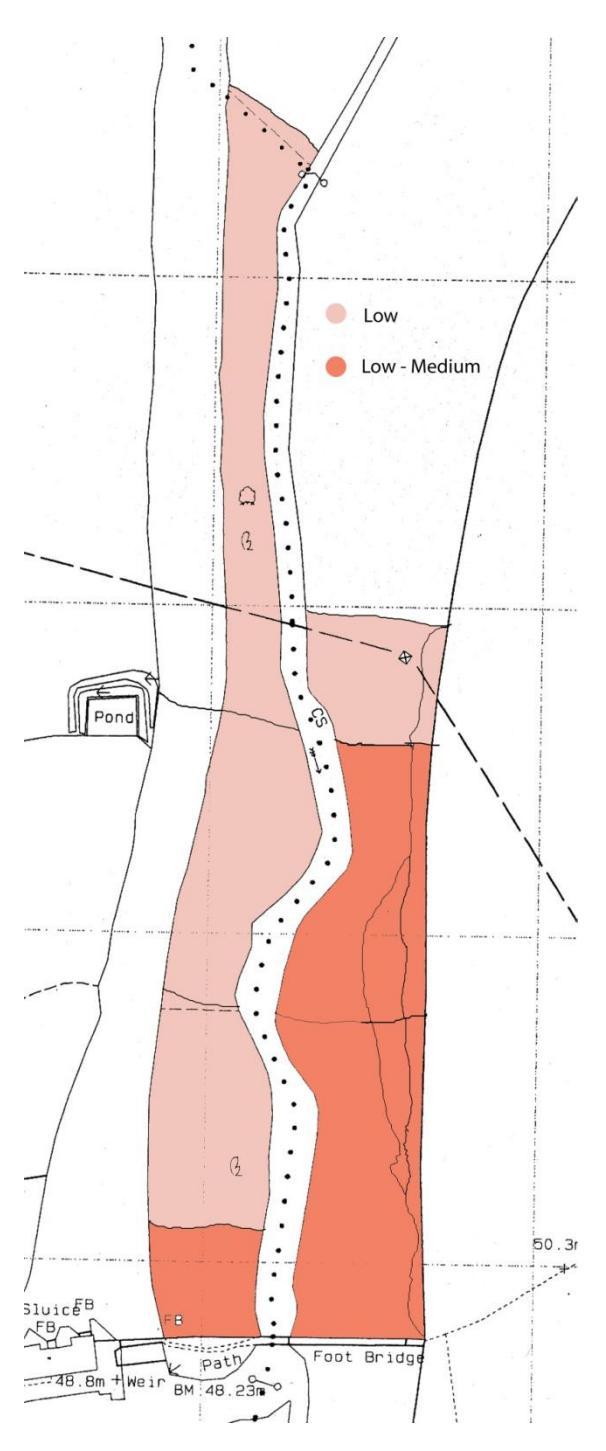
Figure 4 Soil Nitrogen Levels

Soil Mineral content is particularly low. This is probably due to the leaching affect of regular flooding. Nitrogen levels grade roughly from higher concentrations in the south of the site to low levels to the northern end. An opposite pattern can be seen for Potassium. Phosphate levels are so low as to be negligible.
